Q11.4 – 667 Words

Shelter Hall, Brighton – Phase 2

Description of Contract & Scope

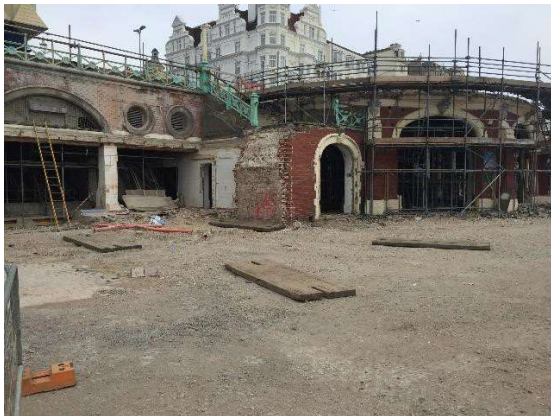
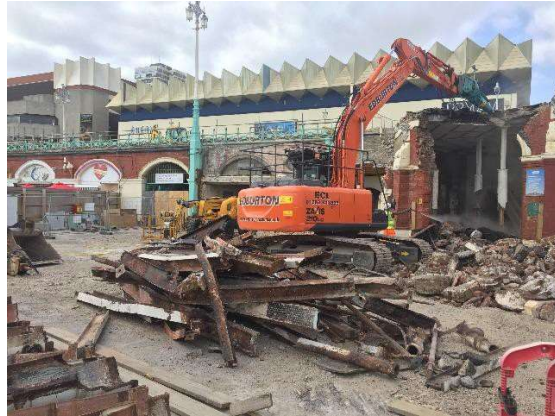
- Installation of a contiguously piled retaining wall with 600mm diameter piles up to 20.0m deep plus an RC capping beam. This was particularly challenging due to a 3.0t weight limit over a large footprint of the site
- Temporary RC bases within the original building supported on mechanical screw piles to be used for temporary propping prior to demolition
- Permanent RC retaining walls within the original building prior to demolition to be used as temporary works during demolition
- Installation of RMD Kiwkform raking shores
- Robotic and traditional demolition

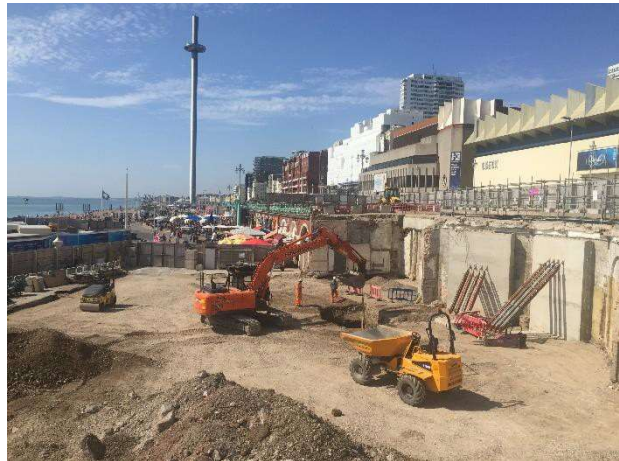
Due to the 3.0t weight limit imposed on the Shelter Hall roof we had a very limited footprint within which to operate. Through early engagement with piling specialists Van Elle to select a compact but high performing piling rig, use of the lower prom for craneage and the storage of reinforcement we were able to keep all pedestrian and vehicular routes open as well as having zero effect on neighbouring business premises
